SUBJECT: Report on Project Assessment of the follow-Up on the Nassriya Prison Facility, Nassriya, Iraq (Report Number SIGIR PA-08-131)

#### **SIGIR PA-08-131**

**April 17, 2008**

# Follow-up on the Nassriya Prison Facility, Nassriya, Iraq Synopsis

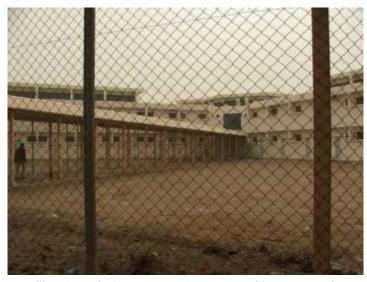
Site Photo 3. Entrance and walkway of inmate housing

each of the four wings for a total of 200 cells per building (Figure 4). Site Photo 3 shows the exterior walkway leading into the entrance of one inmate housing unit.

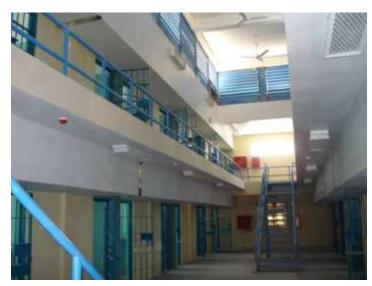
Site Photo 4. Inmate housing corridor one of four (Photo courtesy of the USACE)

The four wings of each inmate housing unit were connected to a central core area located on the ground level. The central core area contained a control room and control stations for each wing, a medical office, a pharmacy, as well as rooms for a barber shop, and a commissary for prisoners. Site Photo 4 shows the central core area leading to one wing of the inmate housing unit. The quality of workmanship exhibited in the inmate housing areas was satisfactory.

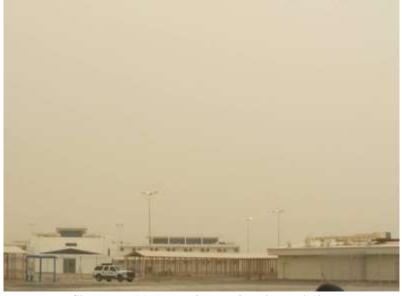
Site Photo 11. Intake/release/medical building

The structural design required a foundation that consisted of isolated reinforced concrete pad footings (2-m x 2-m) supporting reinforced concrete column pedestals (400-mm x 400-mm) and reinforced concrete grade beams. The structural frame of the building included columns, roof joists, and purlins. During our site assessment, we inspected the foundation work and structural steel frame, both of which were complete (Site Photo 11). We were unable to inspect the inside of the building because the doors were locked and the contract workers were unable to locate the keys; however, the construction appeared to meet design requirements.

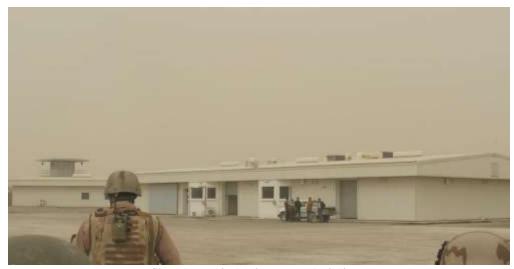
Site Photo 12. Maintenance building

The maintenance building is another pre-engineered building with a similar foundation and structural design as the intake/release/medical building. The 38-m x 17.1-m maintenance building includes a vehicle maintenance area, workshops, and equipment and material storage rooms. Site Photo 12 shows the exterior of the maintenance building. Due to time restrictions, we were unable to inspect the interior of the building. However, the exterior work observed appeared to be consistent with the design requirements.

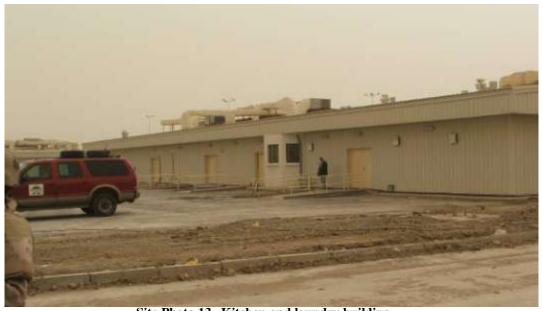
Site Photo 13. Kitchen and laundry building

At the time of our site visits, the kitchen and laundry building was constructed. However, furnishings such as washers, dryers, and ovens were not yet in place. The contractor turned on the electricity during our inspection of the buildings interior. The building's exterior and interior appeared to be consistent with the design requirements.

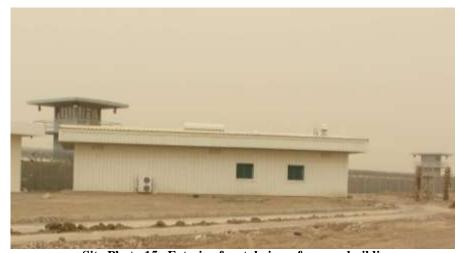
Site Photo 15. Exterior frontal view of prayer building

Site Photo 15 shows the exterior of the prayer building. The 18-m x 10.2-m prayer building architectural design included prayer rooms and ablution facilities (Figure 7). The building is the smallest sized pre-engineered building at the prison. In keeping with the local Iraqi tradition of not entering the prayer room with dirty feet, the contractor provided a separate restroom (ablution unit), which will allow prison staff the opportunity to wash their feet prior to entering the prayer room. At the time of our site visit, the prayer building was complete. However, in order to not disturb the prayer room, we did not enter the facility. The building's exterior appeared to be consistent with the design requirements.

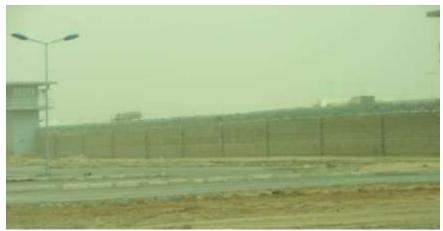
Site Photo 21. Prison parking lot

The other prison facilities that we viewed were the access road, the visitor/employee parking lot (Site Photo 21), and the covered search pit (Site Photos 22 and 23). The 160-space parking lot was complete with traffic islands, curbing, and pavement base constructed. At the time of our inspection, the covered search pit had a foundation, and the structural steel cover was completed.

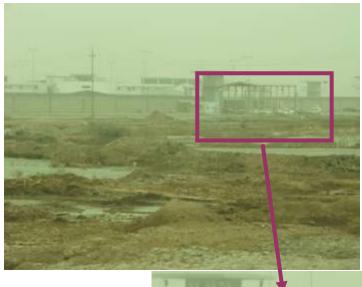
Site Photos 22 and 23. Covered search pit and close-up

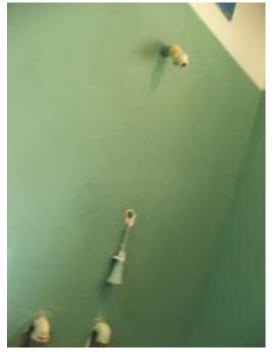
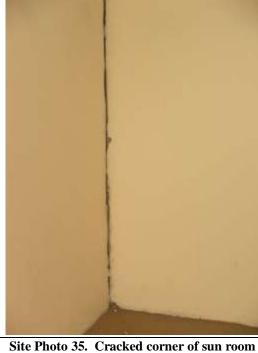
The contractor was performing pre-final checks on the water distribution lines, electrical distribution network, sewage treatment plant, and the prison buildings. Although the SIGIR inspection team did not observe any problems with the water distribution lines, upon our return to the International Zone, we were informed that the International Narcotics and Law Enforcement Affairs (INL) had noted some deficiencies with the Nassriya Prison. When the SIGIR inspection team discussed the issue with the INL representative, he agreed the deficiencies he was referring to were typical punch list items. We followed up with GRS representatives who stated that after our site visit, the water had been turned on to test the plumbing within the prisoners' cells. During the water testing, some leaks were discovered and were being repaired. Again, the GRS representatives stated that all deficiencies would be addressed prior to the issuance of final payment to the contractor.

Site Photo 34. Punch list item – missing shower head

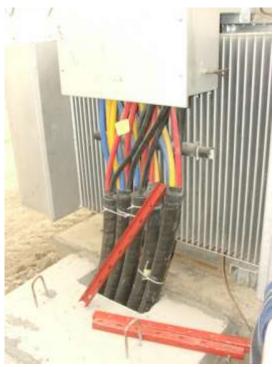
Site Photo 36. Exposed generator cables going to substation plant
